Technical Bulletin

1008 – Inspection of Glass Faults

March 2022 - V1.0

TB 1008 – Inspection of Glass Faults

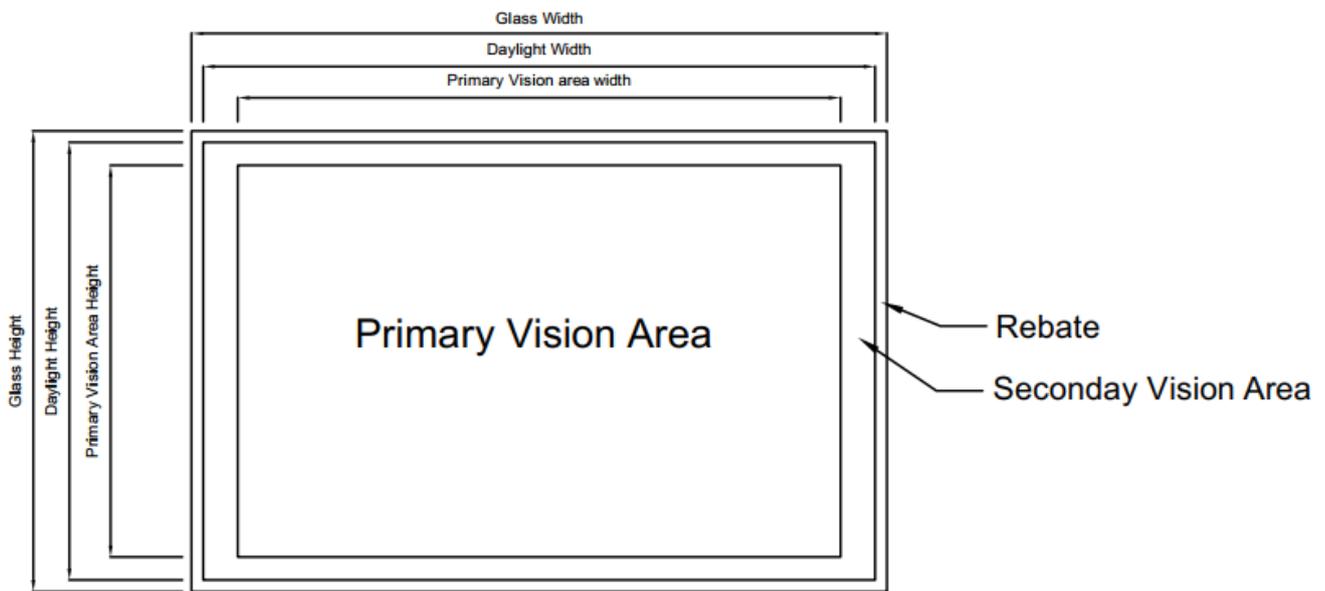
During inspection, the very edges of glass that will be inside the rebate (frame around the edges) is ignored as it will be hidden from view by the frame. The visible glass size is referred to the daylight size, and is split into two areas: Primary and Secondary vision areas. The secondary vision area is defined as an outer strip forming 10 to 15% of the total daylight size as per **AS 4666** tables 5.5 and 5.6. The remaining central section of the glass is the Primary vision area.

1. View glass from a distance of 3m inside the room whilst facing square on to the glass.
2. Maximum viewing time of 60 seconds.
3. Any scratch or bubble visible in the primary vision area following points 1 and 2 above is a defect.

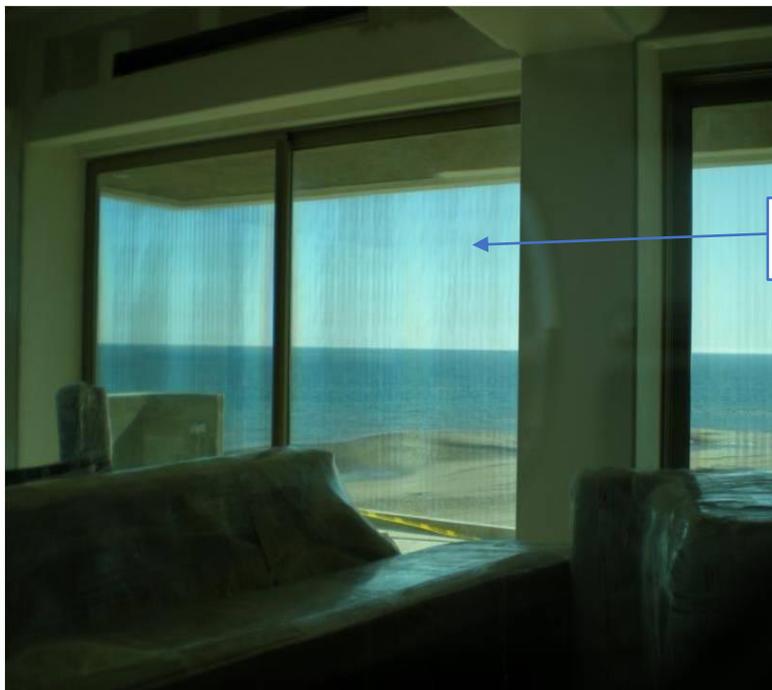
Anisotropy is when the surface of heat treated glass appears to have light and dark patches when polarised light is reflected from it. It is caused by the tempering process and is most commonly noticeable when wearing polarised sunglasses or in specific lighting conditions. Anisotropy is an inherent property of tempered glass and therefore is not considered a defect. The effect can also be more noticeable in an IGU with multiple panes of tempered glass.

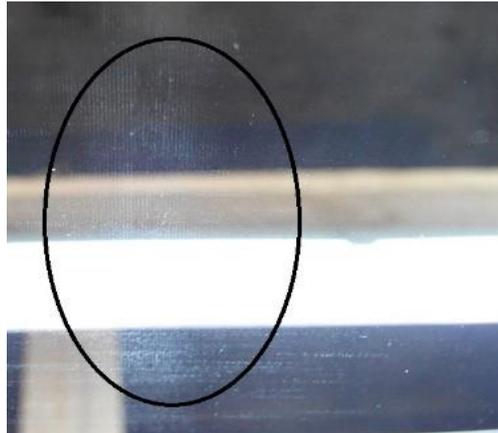
Haze is a light milky visual appearance in the glass when visible light contracts the glass. Most light passes through the glass, the rest is either reflected, absorbed or scattered. If enough light is scattered then the glass will have a light, milky appearance. Haze is present in all forms of glass, but is not noticeable to the human eye in most glass types. Haze can be noticeable on Hardcoat LowE coated glass. Local lighting conditions compared to background lighting also contribute to how visible haze will be. Haze can appear blue with some coatings, and is very dependent on light intensity and the angle at which light hits the glass. As such, haze can be visible during some times of the day but not others. As haze is an inherent property of all transparent material, it is not considered as a defect. See our **Risk of Haze Guideline** for more detail.

Haze in Hardcoat LowE

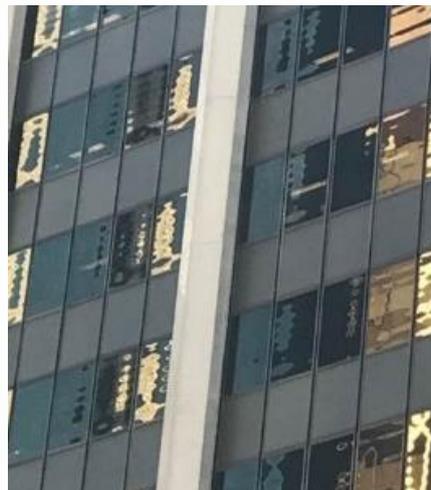
Roller Wave

To toughen glass in a furnace, glass is heated to temperatures in excess of 600°C and becomes soft. The glass is resting on oscillating ceramic rollers of the furnace at this point, so it can take on a slight wave like shape between the gap of each roller. It is then cooled down or 'quenched' by cooler air. As the glass is now cooled, it will retain any wave pattern and is no longer as flat as it was before being in the furnace. Roller wave is more noticeable on reflective or tinted glass. Although not listed in **AS/NZS 4667** or **AS 4666** as a defect, AGG have our own internal quality procedures to keep roller wave to an appreciable minimum.

The above image is an extreme occurrence of roller wave, under normal circumstances roller wave is difficult to see when orientated horizontally and only stands out when the wave pattern is vertical. Therefore, AGG recommend roller wave is orientated horizontally so it will not be noticeable when walking past the glass. This is why glass dimensions of height and width are not interchangeable when ordering glass, as this will determine how glass is orientated on the furnace bed prior to tempering.

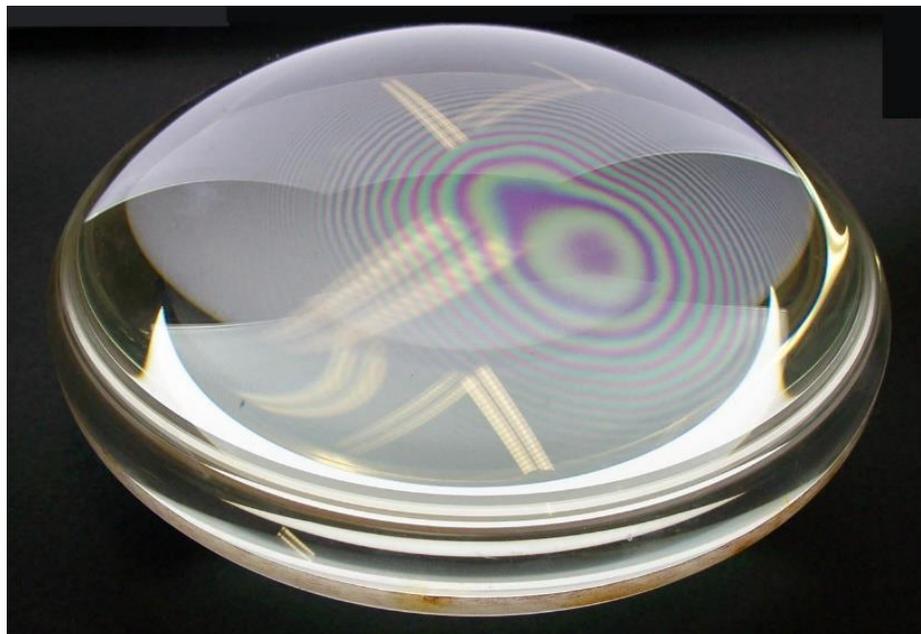
Newton's Rings

An IGU is a flexible pressure vessel and under the right conditions the difference between the air (or gas) pressure inside and outside the IGU can cause both glass panes to deflect towards each other. When they get quite close, rainbow patterned circles can appear on the glass surface, centred on where the gap between the panes is the smallest. These patterns are caused by the varying refraction angles in the surfaces of the glass panes, and is not considered a defect. They can also occur under specific wind pressures. The chance of Newton's rings occurring is reduced by specifying thicker glass, which lowers deflection in each glass pane.
