Technical Bulletin

1011 – Breakage of Toughened Glass

March 2022 - V1.0

TB 1011 – Breakage of Toughened Glass

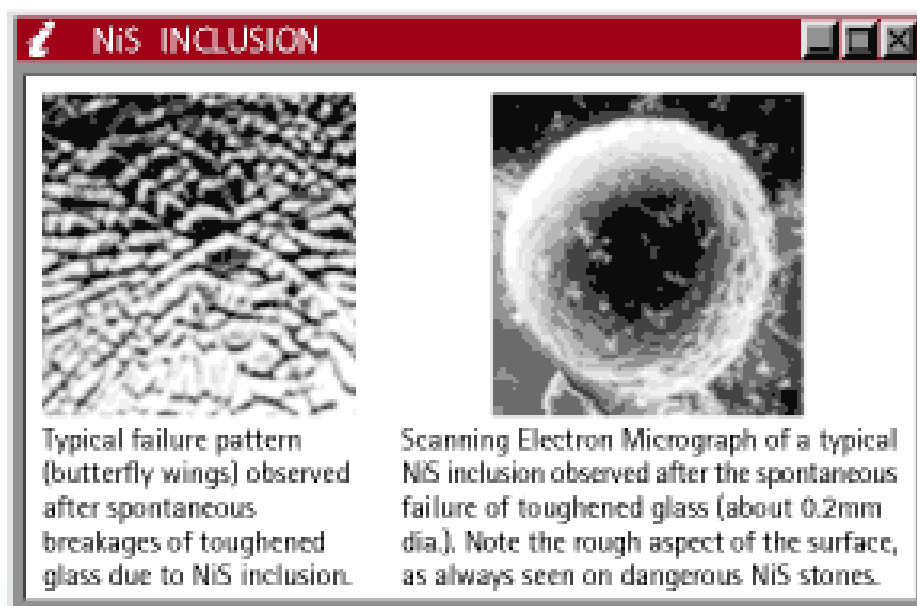
Inclusion stones are very small, typically 0.1 to 0.5mm in diameter and may not be entirely eliminated by automatic online scanners deployed on float glass production lines. Hence, these cannot be fully controlled at the source and may be inadvertently present in the glass prior to processing. These inclusions can change their crystalline phase (Alpha to Beta) whereby these expand some time after the glass was tempered. In tempering, an inclusion stone shrinks more than the surrounding glass during the quench (cooling) stage. The sudden quench 'freezes' the inclusion in its smaller Alpha phase, not giving the inclusion stone sufficient time to make the transition to its' Beta phase where the inclusion is larger and more stable. With the passage of time, the phase change occurs along with a volumetric expansion that introduces stresses within the glass and may shatter the glass from within. The ensuing break pattern in the glass is consistent with the 'dice like' fragments characteristic of toughened glass. The likelihood of spontaneous breakage, however remote, can vary between different batches of glass. At the location of the inclusion, a distinct localised 'butterfly wings' fragmentation pattern occurs and therefore is able to be verified as the cause of breakage.

AGG recognise that toughened glass is prone to spontaneous breakage for the aforementioned reasons as stated above, and offer specialized heat soak testing of toughened glass to minimise the possibility of spontaneous breakage as an additional processing option.
