Technical Bulletin

1008 – Inspection of Glass Defects

December 2021 V1.0

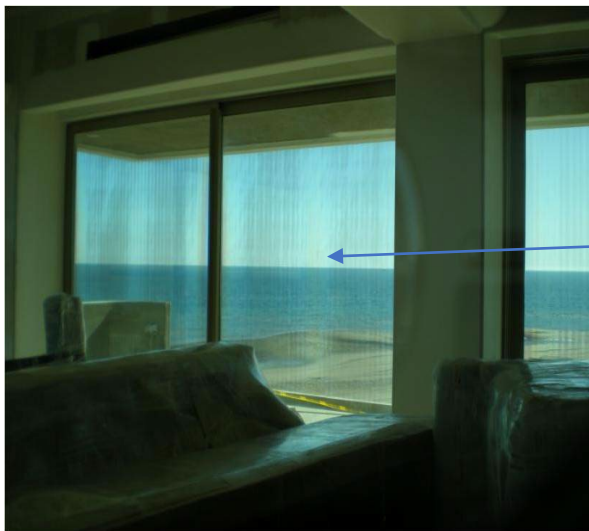
Anisotropy is when the surface of glass appears to have light and dark patches when polarised light is reflected from it. It is caused by the tempering process and is most commonly noticeable when wearing polarised sunglasses or in specific lighting conditions. Anisotropy is an inherent property of tempered glass and therefore is not considered a defect. The effect can also be more noticeable in an IGU with multiple panes of tempered glass.

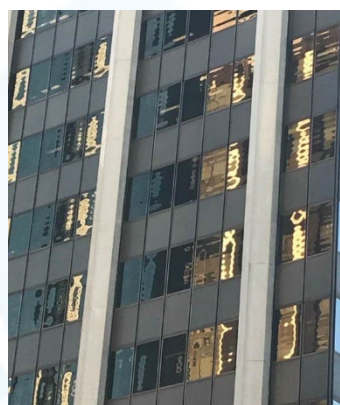
To temper glass in a furnace, glass is moved into the furnace itself by means of mechanised rollers, much like a conveyor belt. The glass is then heated to temperatures in excess of 600°C and becomes soft. The glass is still resting on the rollers at this point, so it takes on a slight wave like shape. It is then cooled down or 'quenched' by large fans in a separate compartment whilst still on said rollers. As the glass is now cooled, it will retain the wave pattern and is no longer as flat as it was before being in the furnace. Roller wave is more noticeable on reflective or darkly tinted glass. Although not listed in AS 4666 or AS/NZS 4667 as a defect, AGG have our own internal quality procedures to keep roller wave to an appreciable minimum.

Roller wave is most visible on reflective glass

Above is an extreme occurrence of roller wave, under normal circumstances roller wave is difficult to see when orientated horizontally and only stands out when the wave pattern is vertical. Therefore, AGG recommend roller wave is orientated horizontally so it will not be noticeable when walking past the glass. This is why glass dimensions of height and width are not interchangeable when ordering glass, as this will determine how glass is orientated on the furnace bed prior to tempering.
